**Flood Control Project Maintenance
Levee Inspections**

Fall 2013 Levee Maintenance Deficiency Summary Report

Sutter Maintenance Yard Tisdale Bypass

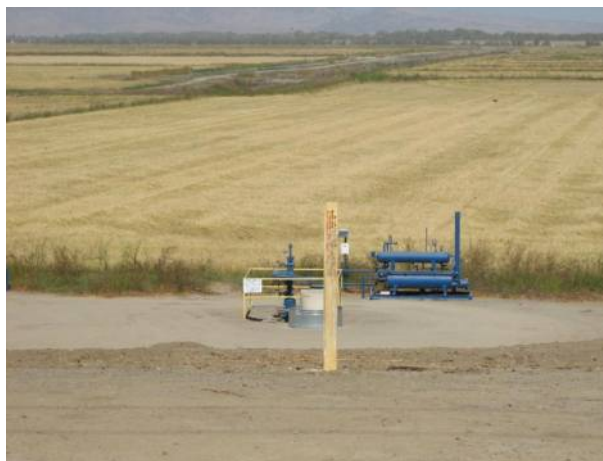
Levee Mile Report Line	5
Start Levee Mile	3.64
End Levee Mile	3.64
Location	Land Side
Category	Supplemental
Item	DWR UCIP Field Study

Carsonite sign on LS shoulder with view of gas well in background.

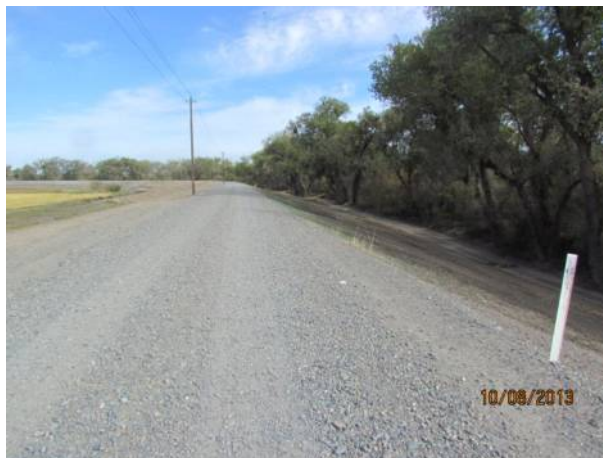
Levee Mile Report Line	6
Start Levee Mile	3.66
End Levee Mile	3.66
Location	Land Side
Category	Earthen Levee
Item	Vegetation

DWR ID: DWR_ST0009_01_f_2013_1										
6	3.66	3.66	Earthen Levee	Vegetation	LS	A Ma	V1 : Control annual grass and weeds on the levee slopes and easements. Inspector Comments: Sutter Yard has burned and dragged both slopes.	39.027898 ° -121.753837 °	39.027898 ° -121.753837 °	6 Y
DWR ID: DWR_ST0009_01_f_2013_6

View of the burned and dragged slopes of the levee.

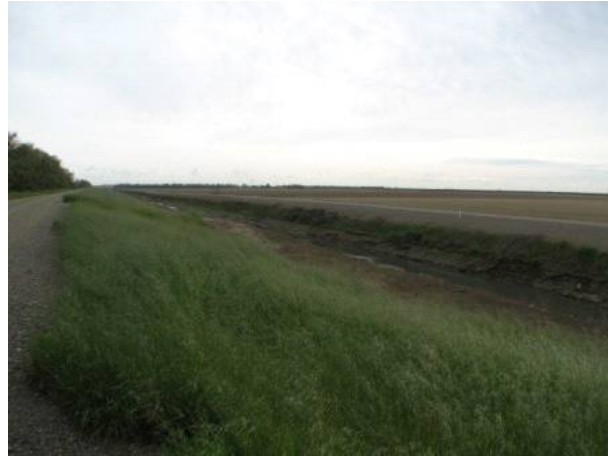
Levee Mile Report Line	1
Start Levee Mile	0.11
End Levee Mile	0.25
Location	Land Side
Category	Earthen Levee
Item	Encroachments

View of the agricultural ditch and erosion along the landside toe of the levee.

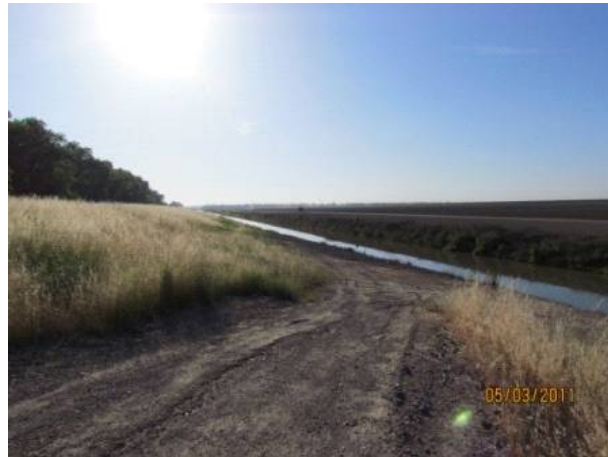
Levee Mile Report Line	2
Start Levee Mile	0.52
End Levee Mile	1.74
Location	Land Side
Category	Earthen Levee
Item	Encroachments

View of the ag ditch next to the L/S toe.

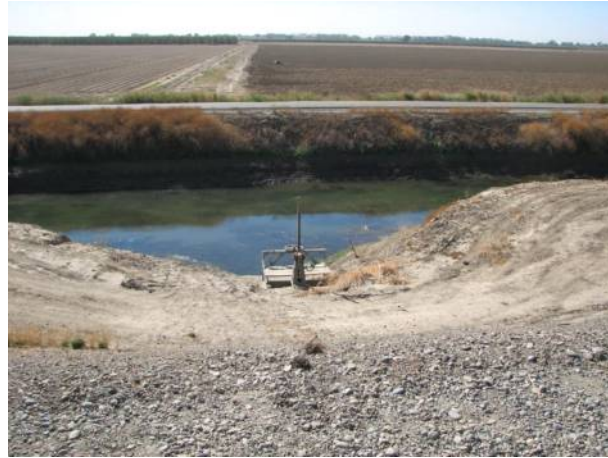
Levee Mile Report Line	4
Start Levee Mile	1.14
End Levee Mile	1.14
Location	Water Side
Category	Supplemental
Item	DWR UCIP Field Study

Slide gate at concrete outlet on LS toe.

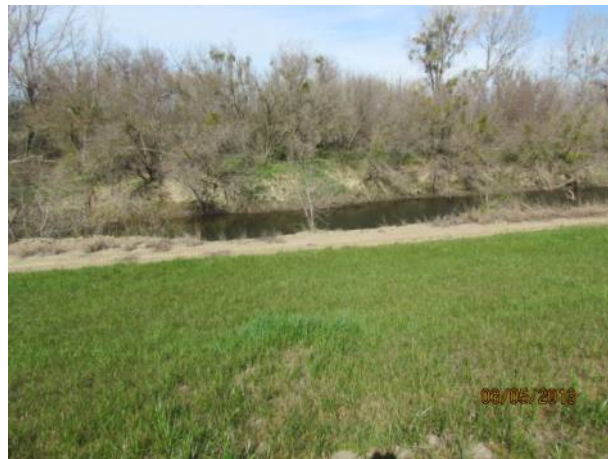
Levee Mile Report Line	7
Start Levee Mile	1.29
End Levee Mile	1.29
Location	Water Side
Category	Earthen Levee
Item	Erosion / Bank Caving

View of the erosion along the waterside berm.

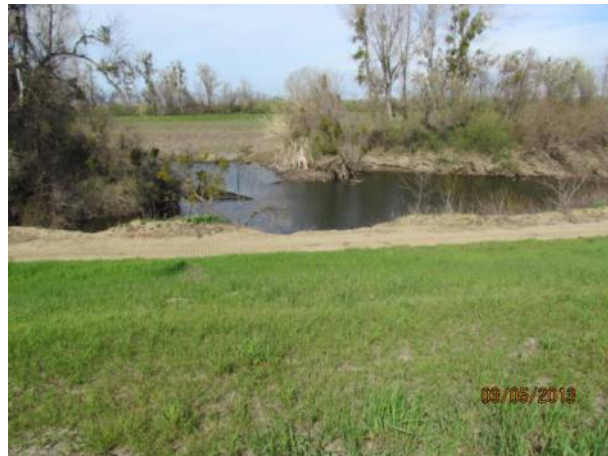
Levee Mile Report Line	8
Start Levee Mile	1.50
End Levee Mile	1.50
Location	Water Side
Category	Earthen Levee
Item	Erosion / Bank Caving

View of the erosion along the waterside berm
